*Type B Accident
Investigation
Board
Report on the
Drum Explosion at
Building C-746-Q,
Paducah Gaseous
Diffusion Plant*

Oak Ridge Operations
U.S. Department of Energy

INDEPENDENT REPORT

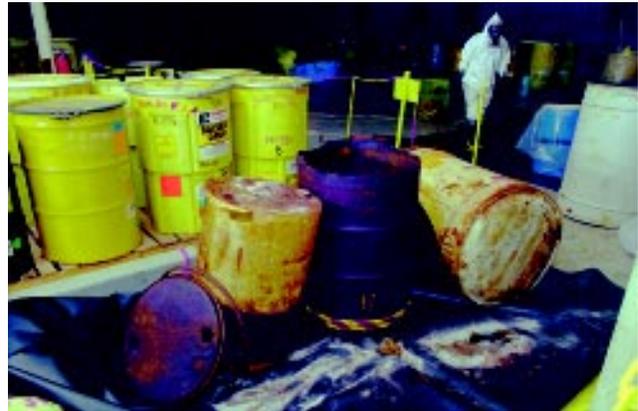
Exhibit ES-1. Components of HC-1093.

ERT discovered an open 110-gal, polyethylene-lined, steel drum (HC-1093) without a lid. Further investigation identified a 55-gal composite steel/polyethylene drum inside HC-1093. (Note: Although not known at this time, additional information discovered later revealed that the accident in-

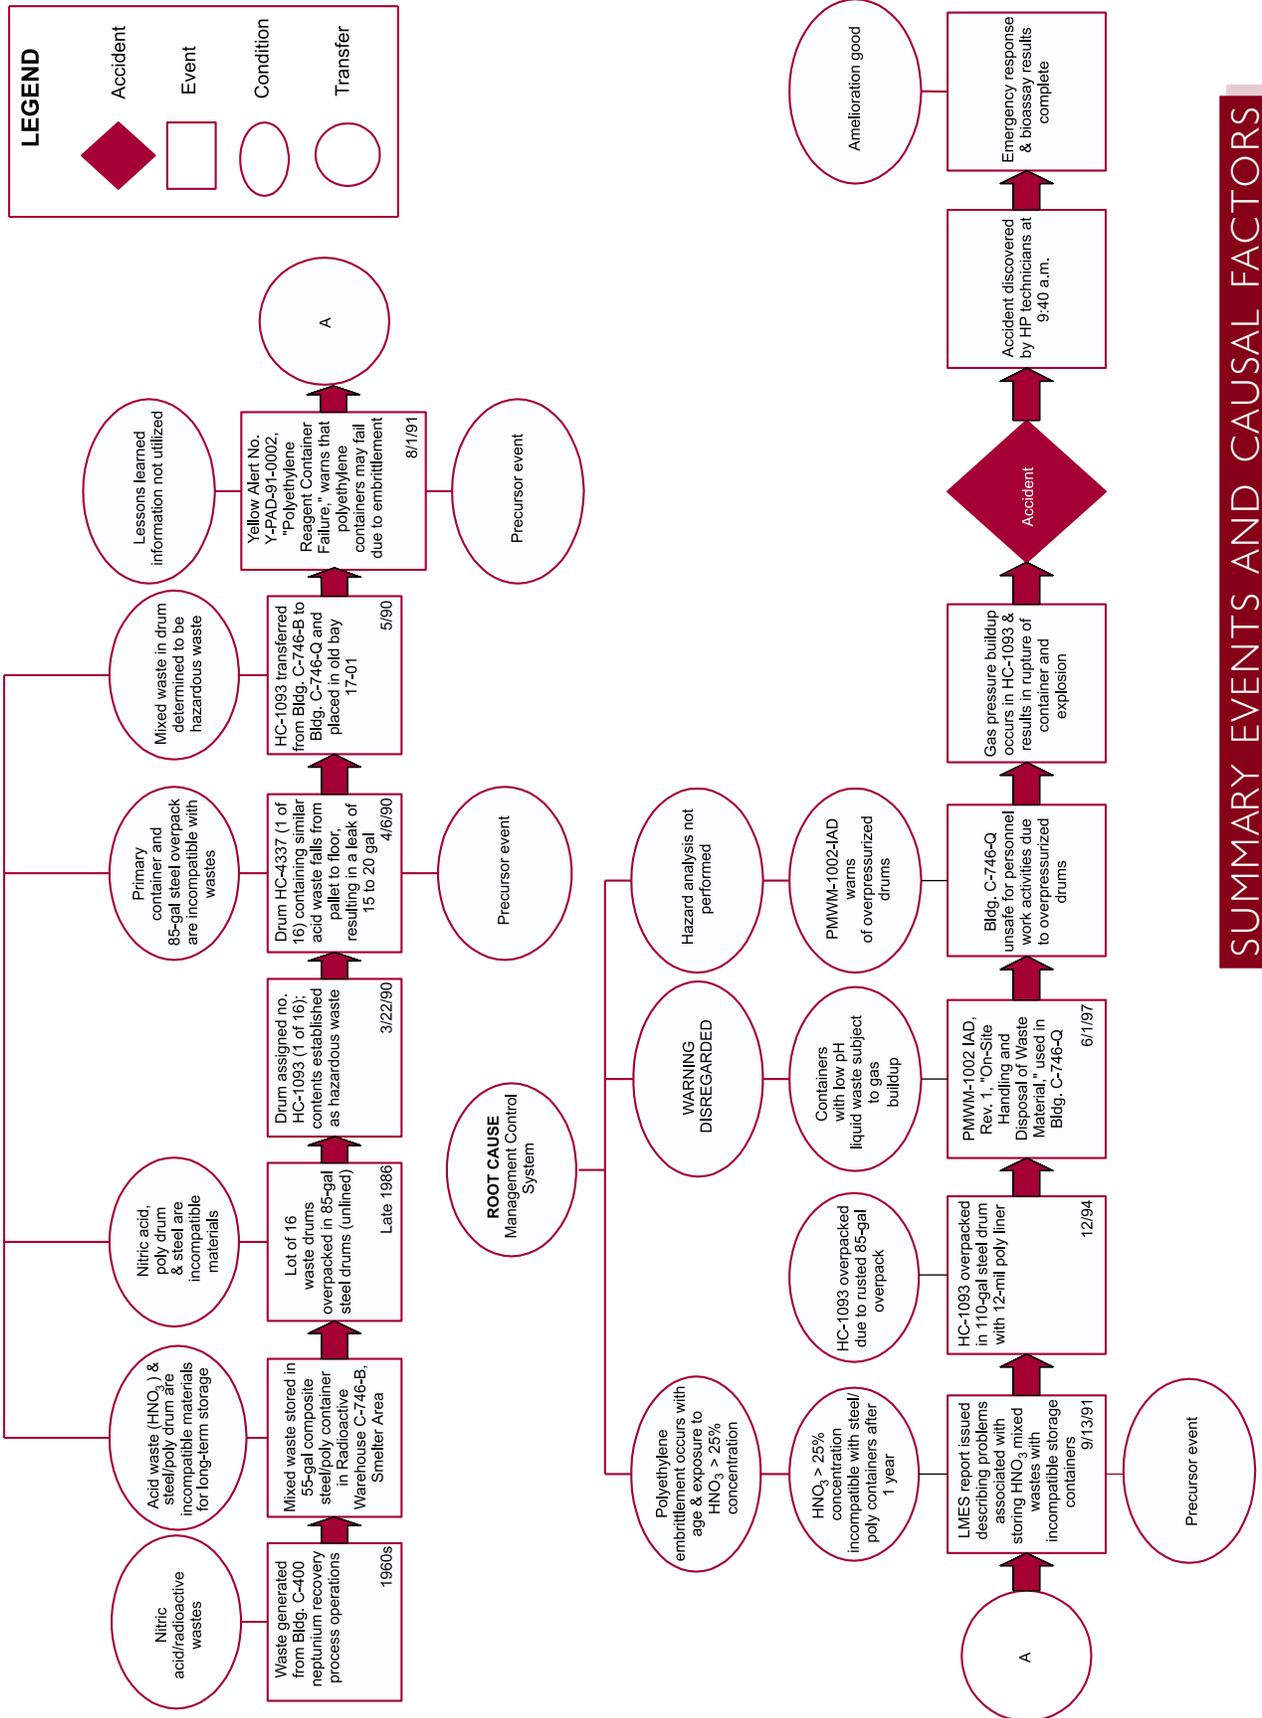
Figure ES-1. Summary Events and Causal Factors Chart

The **direct cause** of the accident was the excessive buildup of pressure due to chemical reactions within the container, resulting in an explosion of the container. However, there were also **contributing causes** (causes that, if corrected, would not by themselves have prevented the accident but are important enough to be recognized as needing corrective action) and a **root cause** (a fundamen-

tal cause that, if corrected, would prevent recurrence of this and similar occurrences). Causal factors are identified in *Table ES-1*, with a short discussion of each cause.

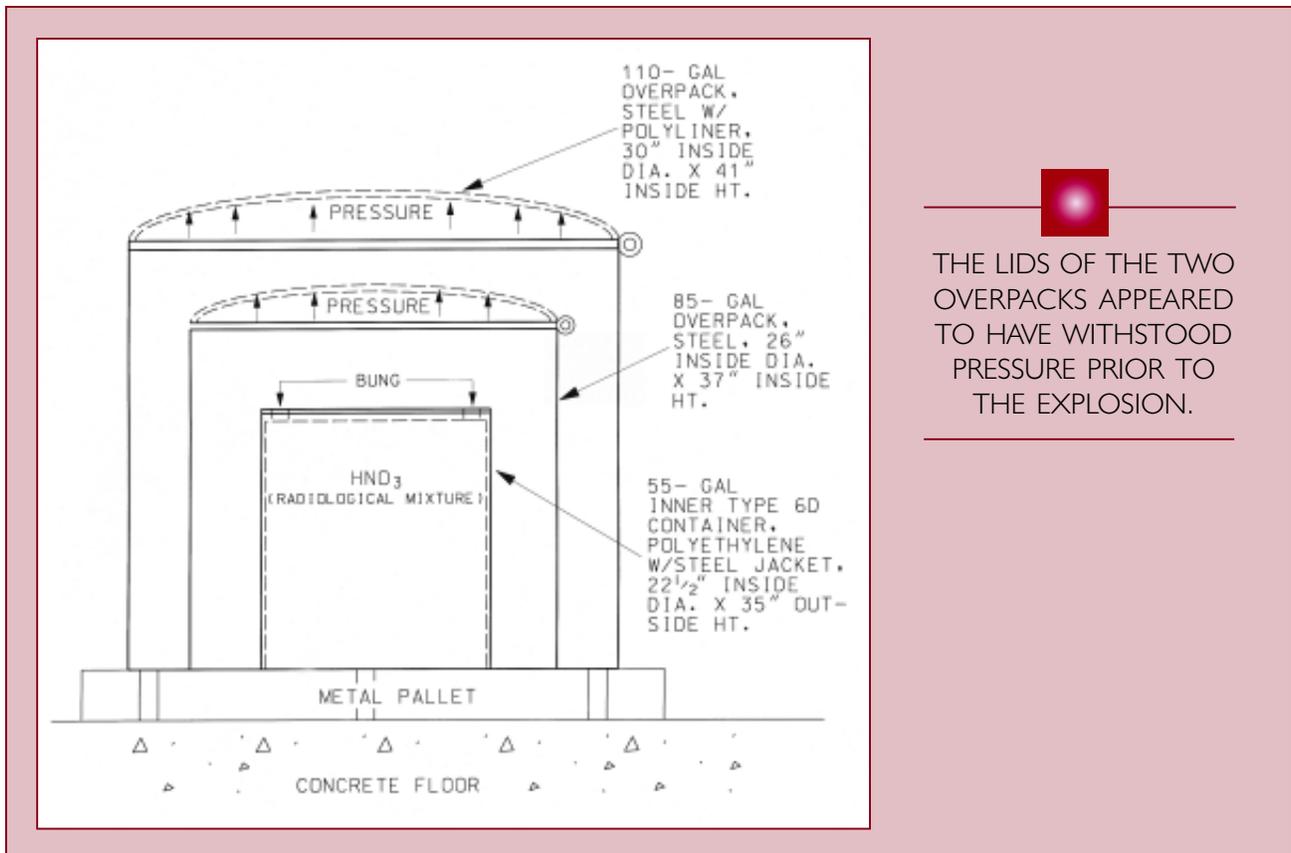
Figure 2-1. Overpack Configuration Prior To Explosion.

- 55-gal composite steel/polyethylene drum. The polyethylene drum was the innermost drum of the configuration. There were two bungs located on the top of the drum that were in place and tightly closed. The polyethylene drum was brittle. The drum contained a 12- to 15-in. horizontal breach approximately 1 in. from the top. On the bottom, a 24- to 26-in. breach near the side and a thin 10-in.-diameter area in the polyethylene were found. Within this thin area was one 4-in. breach. All that remained of the 55-gal steel drum surrounding the polyethylene drum was the lid, the ring, and approximately 14 to 16 in. of the area nearest the top. The remains of this steel drum were rusty, corroded, brittle, and thin.

- 85-gal steel drum (first overpack). This drum was the middle drum in the configuration. This drum was ejected from the configuration and found lying on its side approximately 15 ft away from its original location in an adjacent diked area. This drum contained a drum lid and ring in place on the drum. The drum lid was convex, giving

the appearance that it may have withstood pressure prior to the explosion. The bottom inch of the drum was missing, leaving an open container. The drum was rusty overall, with a rough and jagged bottom edge.

- 110-gal steel, polyethylene-lined drum (second and outer overpack). This drum was the outermost drum in the configuration. This drum was found with the drum ring in place on the drum, but the drum lid had been blown off. The drum lid was found approximately 10 ft away on the floor within the diked area (B-08). The drum lid was uniformly convex, giving the appearance that it may have withstood pressure prior to being blown off the drum. The bottom of the drum was also convex, giving the appearance that it may have withstood pressure prior to the explosion. There were three holes in the bottom of this drum believed to have been caused by acid corrosion after the event. No holes or breaches were visible in the polyethylene liner; however, after the accident, acid material was leaking from this drum.

THE LIDS OF THE TWO OVERPACKS APPEARED TO HAVE WITHSTOOD PRESSURE PRIOR TO THE EXPLOSION.

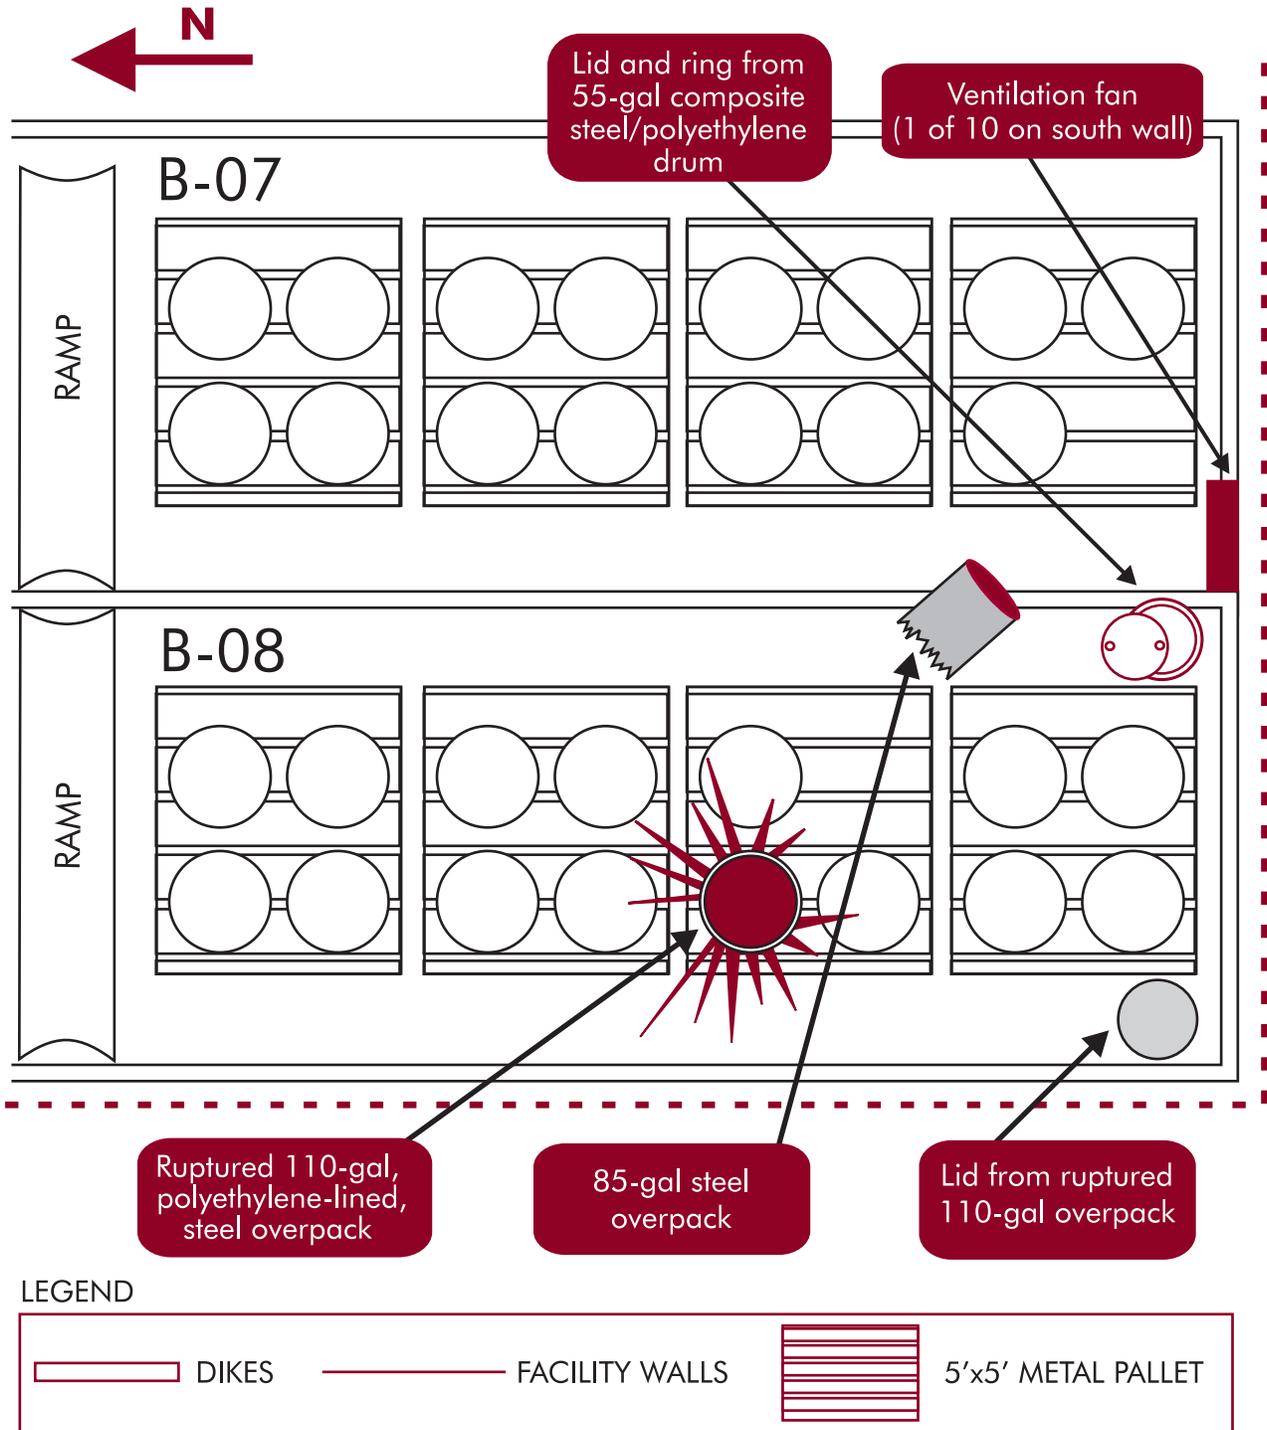
Figure 2-3. Accident Layout.

- The explosion did not displace the outer drum (HC-1093) from its original location. HC-1093 was found with the drum ring in place on the drum, but the drum lid had been blown off. The drum lid was found approximately 10 ft away on the floor within the diked area (B-08). The drum lid was uniformly convex, giving the appearance that it may have withstood pressure prior to being blown off the drum.

- A 55-gal composite steel/polyethylene drum, containing two bungs in the top, was found inside HC-1093.
 - An 85-gal steel drum was ejected from HC-1093, hit the ceiling of Building C-746-Q, and landed approximately 15 ft away from HC-1093. The 85-gal steel drum was lying on its side within an adjacent diked area (B-07) with its lid and ring in place on the drum. The drum lid was convex, giving the appearance that it may have withstood pressure prior to the explosion. The bottom inch of the 85-gal drum appeared to have been corroded by acid.

- A steel drum lid and ring was found lying adjacent to the 85-gal steel drum. The steel drum lid and ring were originally thought to be the lid and ring of the 85-gal steel drum. Closer inspection of the steel drum lid and ring showed that the drum lid had two holes in it (bung holes) and that the ring fit the drum lid. Later, it was determined to be the lid and ring of the 55-gal composite steel/polyethylene drum.
-

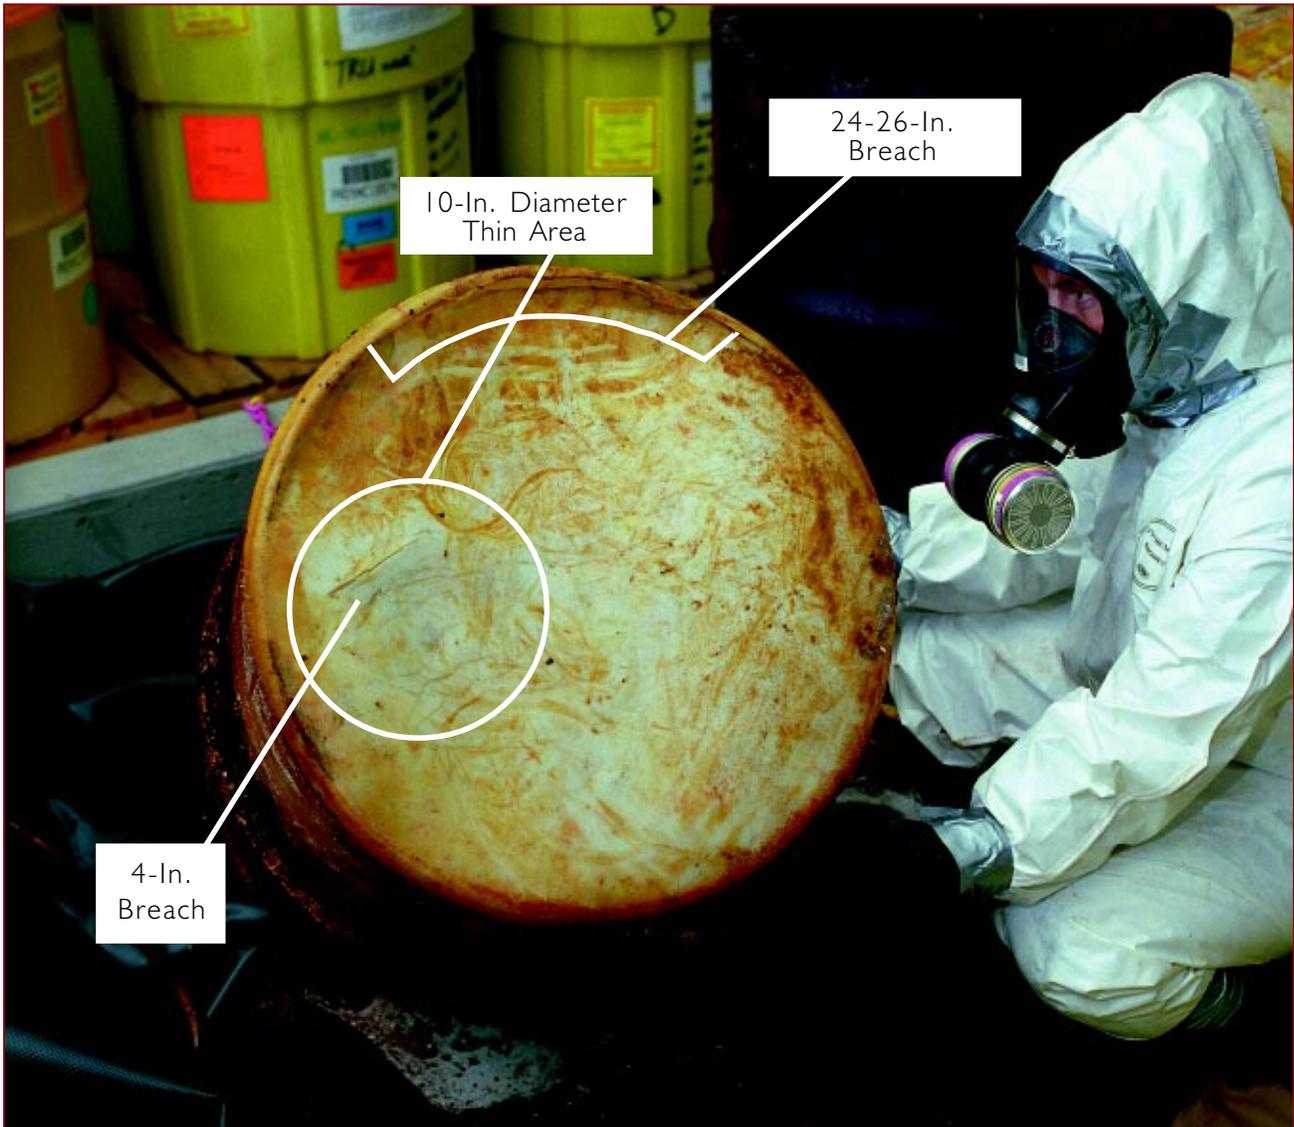
Exhibit 2-2. Bottom of 55-gal Polyethylene Drum.

- The concentrated nitric acid stored in contact with the polyethylene liner over an extended period (from approximately 1960 to 1997) caused the polyethylene liner to become extremely brittle. The concentrated nitric acid slowly seeped through the hairline fractures of the degraded polyethylene liner. During this time, the continual cycle of heating and cooling of the drum contents due to natural environmental conditions as well as the continual degradation of the polyethylene liner induced by the concentrated nitric acid caused “wicking” of minute quantities of escaped acid between the surfaces of the composite steel/polyethylene drum. In this case, wicking means the movement of liquids (condensation and concentrated nitric acid) along the outer walls of the polyethylene liner and the inner walls of the steel drum. The wicking of the concentrated nitric acid resulted in an extremely corroded, thin, and weak 55-gal steel drum. Over time, more and more hairline cracks developed in the polyethylene, weakening this liner.

- It can be seen in **Exhibit 2-2** that the polyethylene drum is very thin within a 10-in.-diameter bottom area. The 4-in. breach in the thin and brittle bottom of the polyethylene drum could have been

caused by the sampling tool (caliwasa) during the sampling event on July 28, 1997. The sampling event and the subsequent movements of HC-1093 provided enough additional stress to the inner polyethylene liner to cause a breach large enough to allow acid to reach a greater surface area of the metal and intensify the acid/metal reaction. The
